GigaUnit Transplant System: A New Mechanical Tool for Transplanting Submerged Aquatic Vegetation

by Deborah J. Shafer

PURPOSE: This technical note describes two case studies in which GUTS was used to transplant seagrasses that were to be unavoidably damaged by proposed construction and dredging activities. The first, located near the Isle of Wight, in the Chesapeake Bay, Maryland, involved transplanting the seagrass *Zostera marina* (eelgrass) (BayLand Consultants & Designers, Inc. 2005). The second involved transplanting the seagrasses *Halodule wrightii* and *Thalassia testudinum* in Sarasota Bay, Florida (Uhrin et al. 2008). Information on operational capabilities and limitations of GUTS is presented, as well as recommendations for further use.

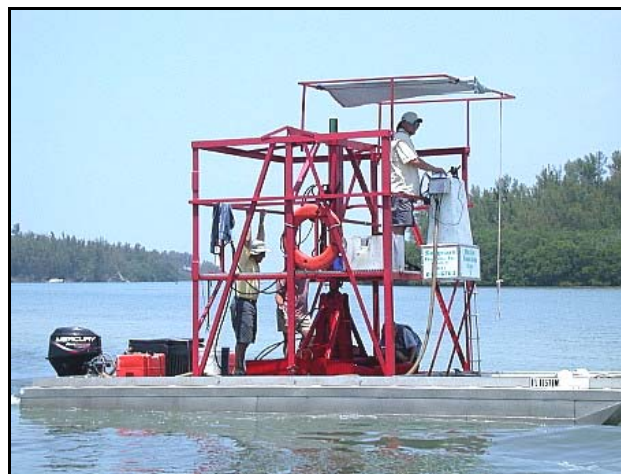
Figure 1. GigaUnit Transplant System. Photo courtesy of Florida Wildlife Conservation Commission, Florida Wildlife Research Institute (FWC).

(ECOSUB), operated by divers, has been used to plant and restore seagrasses in Australia (Paling et al. 2001a, 2001b). In the United States, Seagrass Recovery, Inc. (Ruskin, Florida) has developed and patented several types of mechanical equipment for use in seagrass restoration projects. One of these, the GigaUnit Transplant System® (GUTS) (Figure 1), was designed for the removal, transport, and subsequent replanting of large (1.8-m²) planting units (e.g. “sods”) of intact submerged aquatic vegetation (SAV), complete with roots, rhizomes, and associated sediments. Previous studies in Australia demonstrated that the planting success of large sods of seagrass was greater than that of individual planting units, especially in high wave-energy environments (Paling et al. 2001a, 2001b).

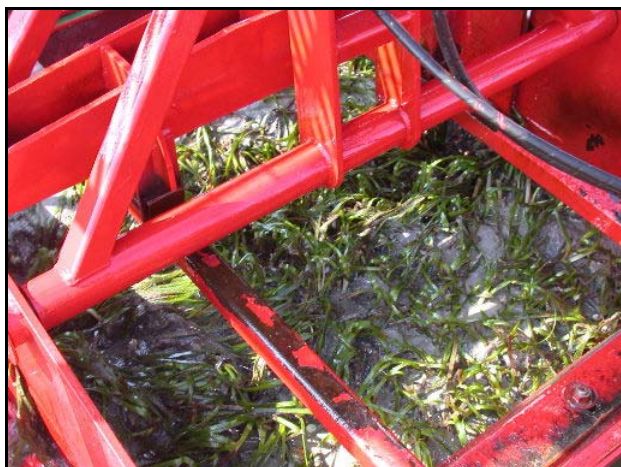
Figure 2. Excavated *Thalassia testudinum* prior to transplant. (Photo courtesy of FWC.)

Planting Operations. Specific locations for collection and replanting were identified by scientific staff, who provided guidance to Seagrass Recovery, Inc. personnel operating the GUTS. In April 2003, 18 *H. wrightii* planting units and 9 *T. testudinum* planting units (Figure 2) were transplanted, for a total of 27. The average distance between each of the planted sods was 8 m; the average distance from the edge of each planted sod and the adjacent existing seagrass bed was 2 m.

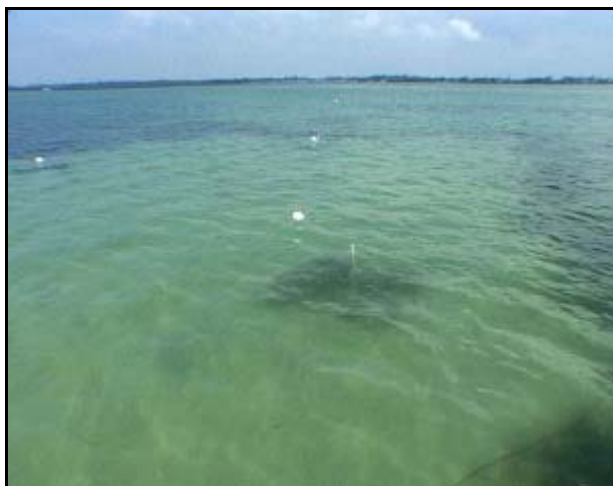
Figure 3. A survey post marks the center of a *H. wrightii* planting unit (Photo courtesy of FWC).

The perimeter of each planted sod was mapped using a surveyor-grade differential Global Positioning System (DGPS) at <0.5 m resolution. Metal stakes were inserted in the center of each sod (Figure 3), and shoot density was recorded in three replicate quadrats (0.125 m x 0.125m) per planting unit. Monitoring was conducted at intervals of 6, 12, 18, 24 and 36 months following transplanting. During this period, measures of survival, shoot density, perimeter expansion, and species composition were recorded.

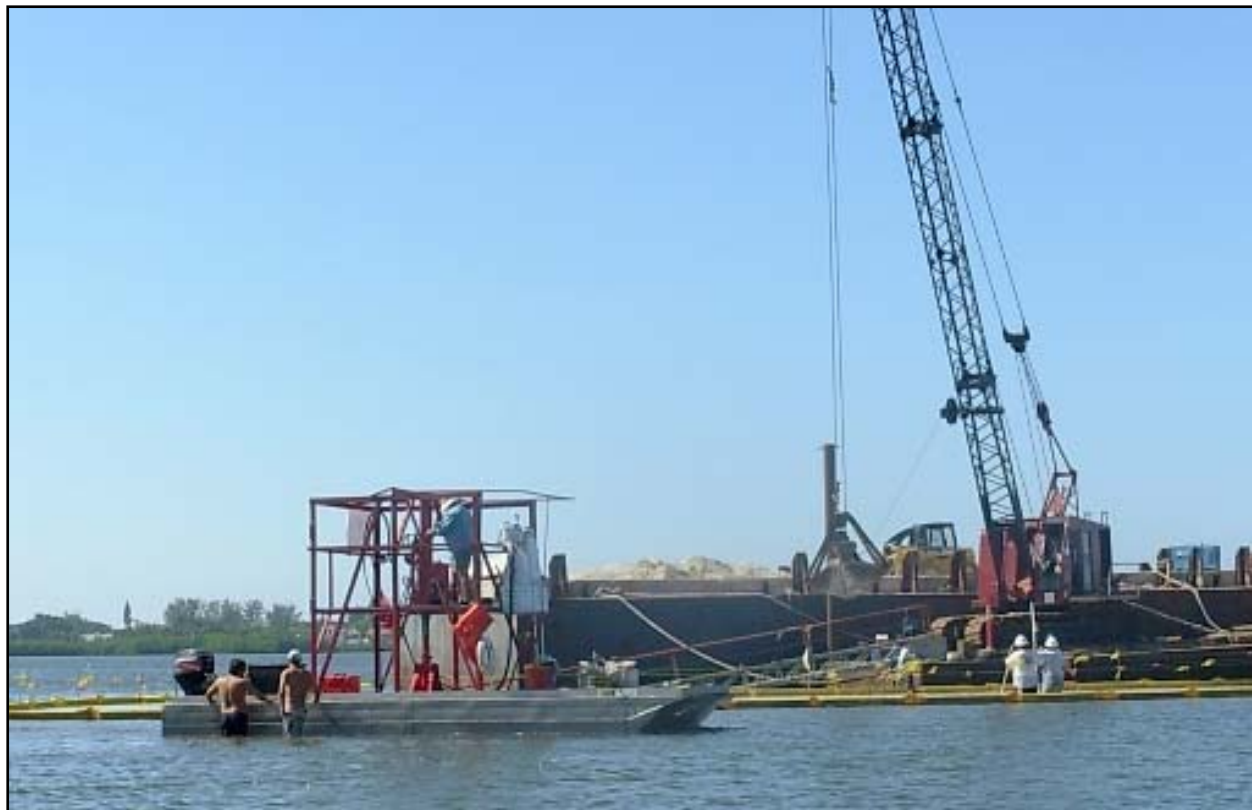
Figure 4. GUTS salvages seagrass near dredging operations in Florida. (Photo by Seagrass Recovery, Inc.)

1. Since GUTS removes large areas of SAV, it is best suited to ‘salvage’ situations where damage to SAV resources is unavoidable. For example, SAV growing in or immediately adjacent to a navigation channel may be physically removed and relocated to reduce damage by dredging operations (Figure 4).
